Watson Island Restoration Project

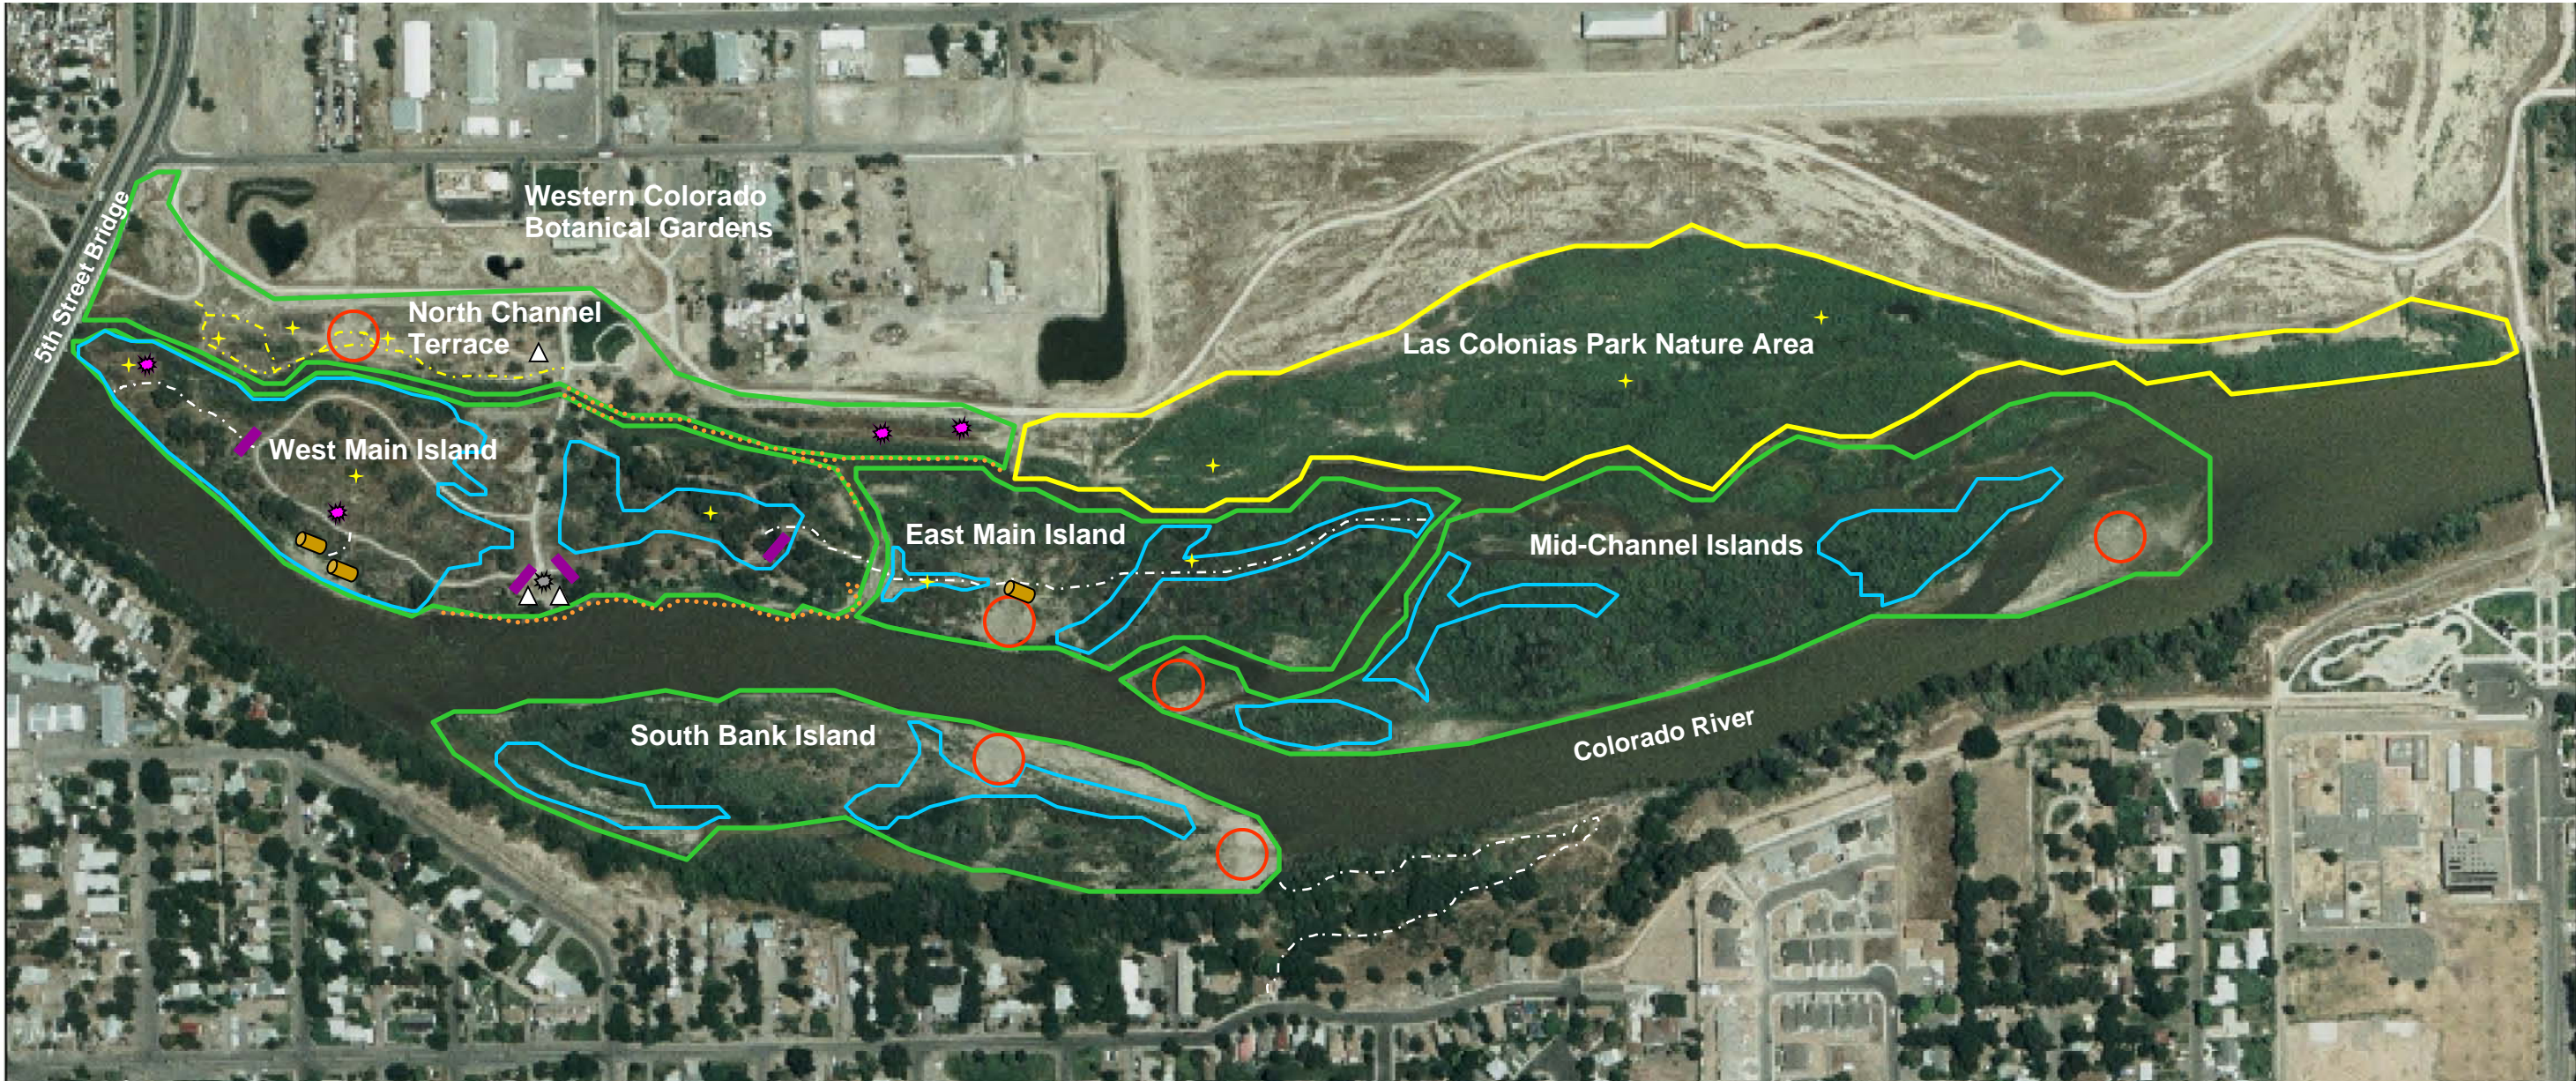
- = upland terrace vegetation zone
- = riparian vegetation zone
- = saline bottomland shrubland vegetation zone
- = possible site for burning brush pile

- = park bench
- ✱ = debris pit to be cleared and filled in by GJ Parks
- ✦ = future site of groundwater monitoring well
- 🪵 = "sitting log" created from felled hazard trees
- △ = interpretive sign or kiosk

- - - = soft trail constructed with wood chips from brush chipped onsite
- - - = ADA accessible trail constructed with StaLok material
- - - = concrete debris rip-rap- Engineered removal may be undertaken as a future project by GJ
